City of Colwood

HUMAN IMPACT ASSESSMENT FOR THE ESQUIMALT LAGOON MIGRATORY BIRD SANCTUARY - DRAFT

August 2025

Prepared by Diamond Head Consulting

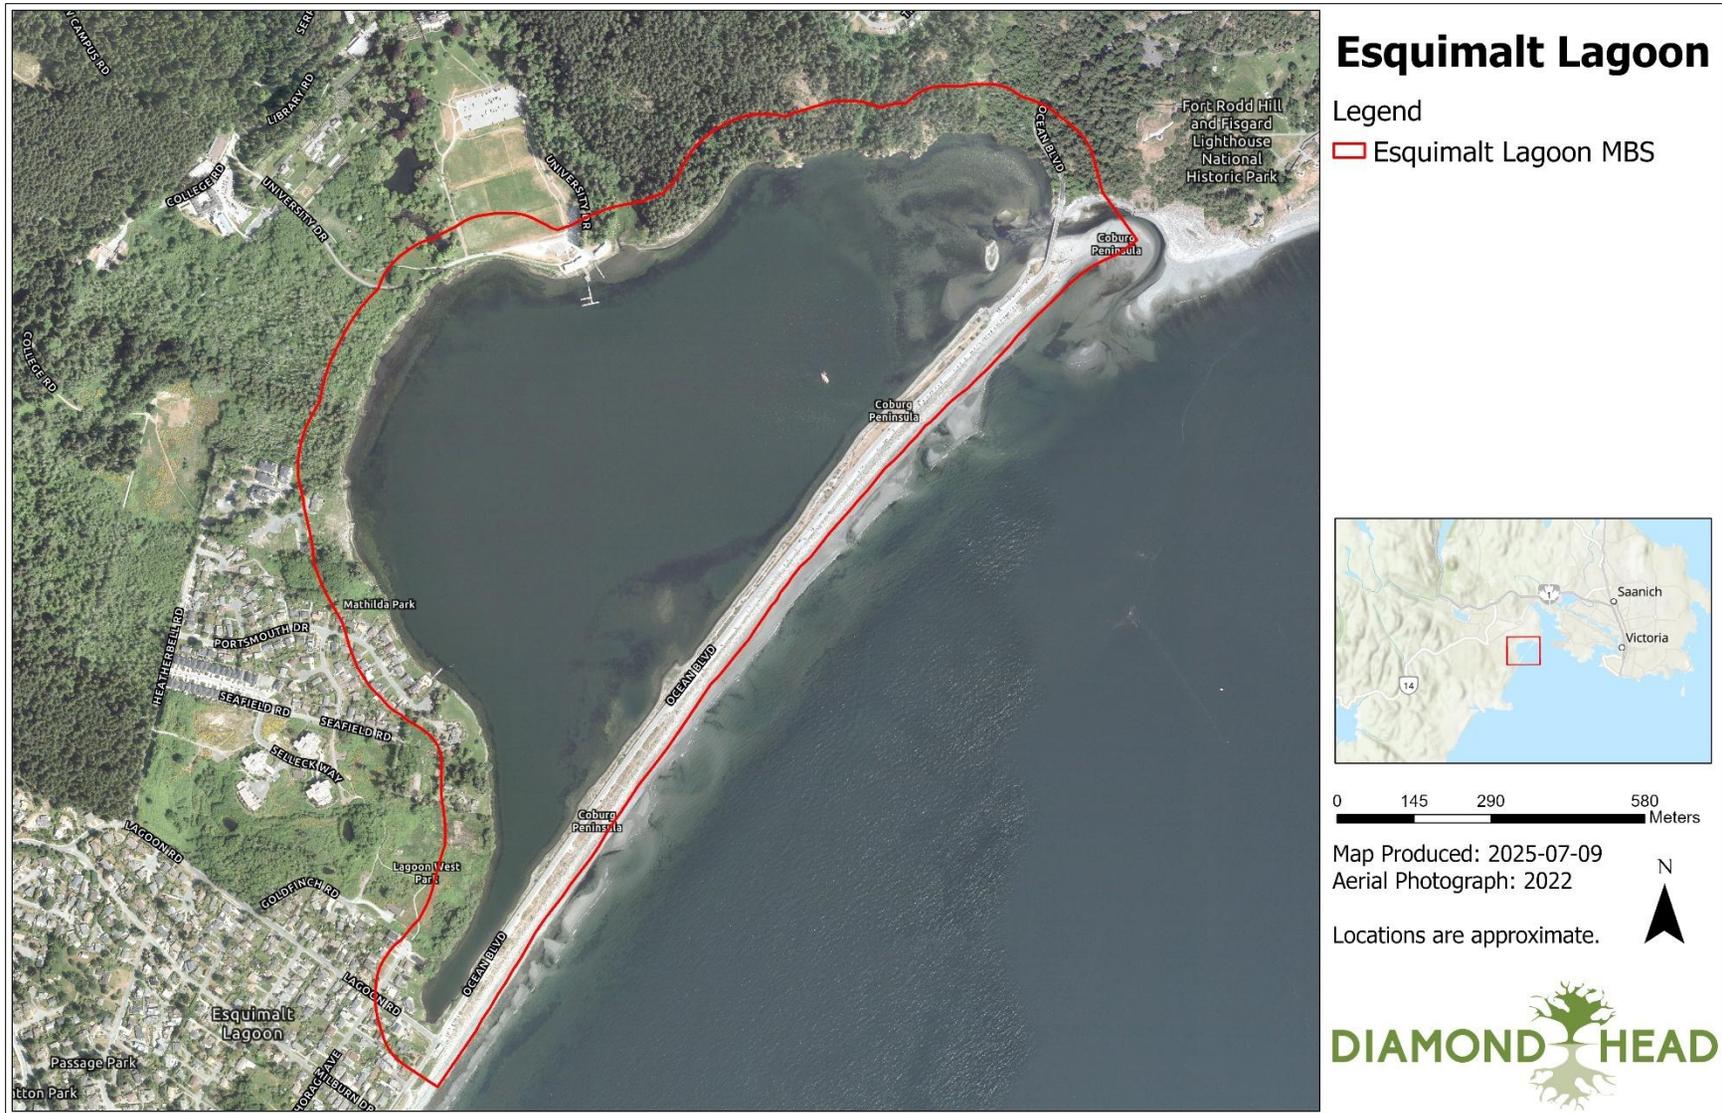
Figure 1. Study area – Esquimalt Lagoon Migratory Bird Sanctuary, located in the City of Colwood, BC.

The City of Colwood is located on the southern tip of Vancouver Island in British Columbia (Figure 1). It is approximately 7 km west of the City of Victoria and is part of the Capital Regional District (CRD). A prominent feature of Colwood’s coastline is Esquimalt Lagoon, which faces southeast toward the Strait of Juan de Fuca. The lagoon is separated from the Strait by the Coburg Peninsula, with a tidal channel at the northeast end of the peninsula that allows water to flow in and out of the lagoon. A two-lane paved road, Ocean Boulevard, bisects the length of the Coburg Peninsula and connects it to Fort Rodd Hill and Fisgard Lighthouse National Historic Park on the northeastern shore of the lagoon via a bridge over the tidal channel. On either side of Ocean Boulevard, where it crosses the Coburg Peninsula, are various areas for visitors to park.

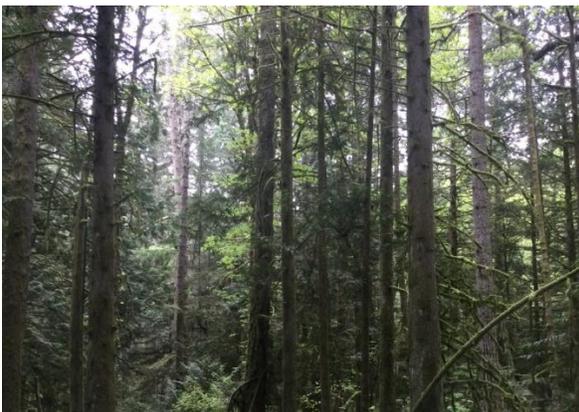
Photo: Typical mature stand of **Ecotype A**.

Ecotype A contains large patches of mature forest that are common throughout the forested portions of the Royal Roads University campus. These mature forests are dominated by Douglas-fir (*Pseudotsuga menziesii*) and western redcedar (*Thuja plicata*), with lesser components of grand fir (*Abies grandis*), arbutus (*Arbutus menziesii*), and bigleaf maple (*Acer macrophyllum*). Trace amounts of Sitka spruce (*Picea sitchensis*) occur in wetter, low-lying areas. Small pockets of site series 02 found on rocky outcrops along the shoreline have a mix of Garry oak (*Quercus garryana*), arbutus, and Douglas-fir. These mature stands typically have a canopy density of around 200 stems per hectare, with 15% crown closure. The largest trees found within the study area were observed in Ecotype A. They include Douglas-fir trees up to 2 m in diameter and up to 50 m in height.

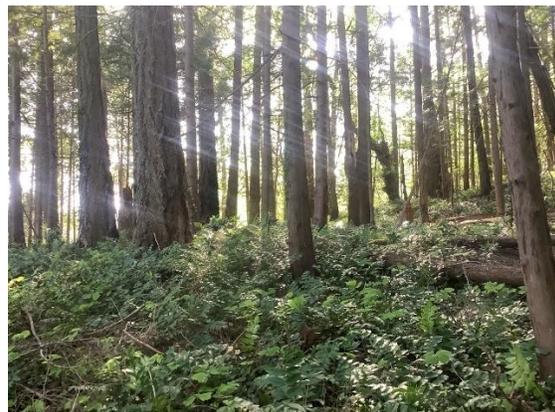
Photo: Typical understory vegetation of **Ecotype A**.

Understory vegetation in Ecotype A is similar within forested areas and on dry outcroppings. Dominant understory vegetation includes dull-Oregon grape (*Berberis nervosa*), oceanspray (*Holodiscus discolor*), snowberry (*Symphoricarpos albus*), vanilla leaf (*Achlys triphylla*), and salal (*Gaultheria shallon*). On dry outcroppings, there are also high concentrations of camas (*Camassia quamash*).

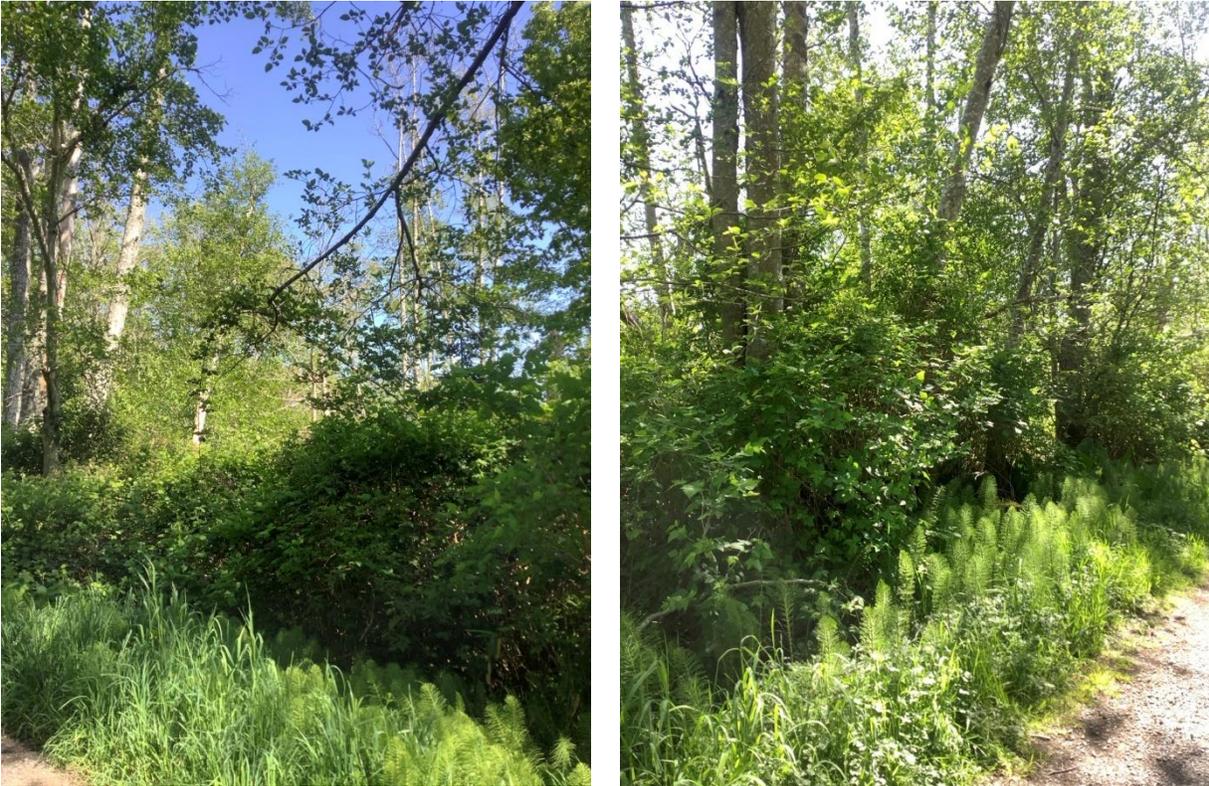
Photo: Representative views of **Ecotype B**.

Scattered mature coniferous trees remain in this area, although dense, younger patches of deciduous forest dominate the majority of Ecotype B. These forests are dominated by single-storied red alder (*Alnus rubra*) stands, with lesser amounts of Douglas-fir and western redcedar. The canopy in these forests is denser than the coniferous forest patches, with approximately 500 stems per hectare and 20% crown closure.

The understory vegetation is consistent with the wet and rich soils found in these stands. Dominant native understory vegetation includes salmonberry (*Rubus spectabilis*), common horsetail (*Equisetum arvense*), skunk cabbage (*Symplocarpus foetidus*), and common bracken fern (*Pteridium aquilinum*).

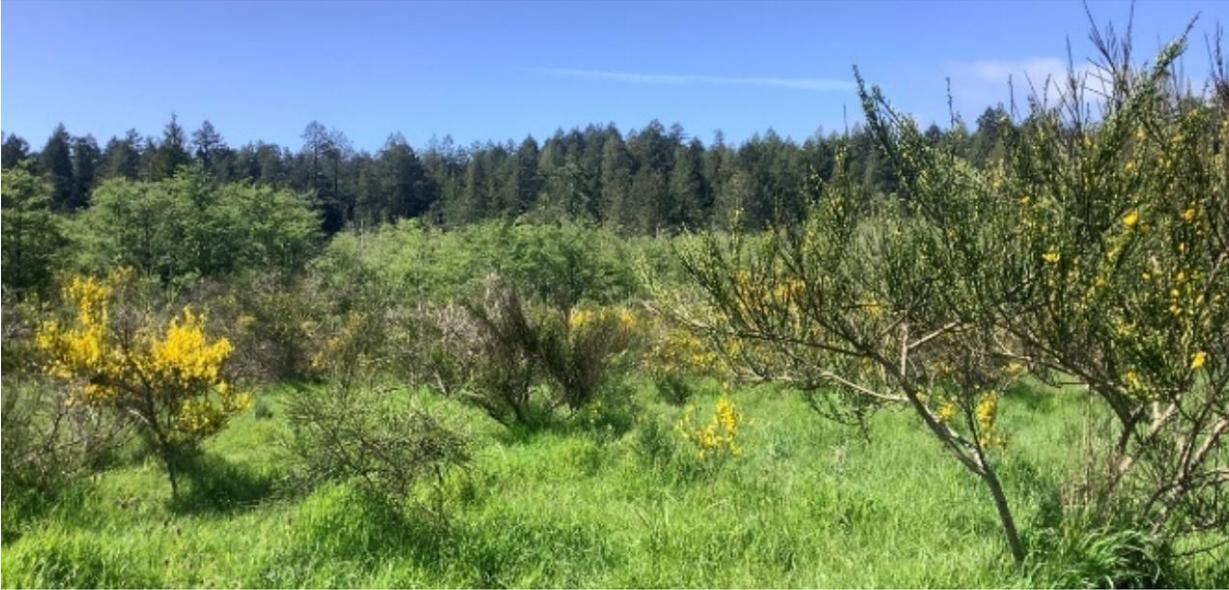
Photo: Representative view of **Ecotype C**, where large, dense infestations of invasive species occur in disturbed areas.

Ecotype C – Grass and Shrubland | Ecotype C includes modified sites that are dominated by grasses and shrubs. This ecotype is mostly found in landscaped areas such as the southern area of the Royal Roads University campus near University Drive, in private residences near the southwestern shore of the lagoon, and in Matilda Park and Lagoon West Park. These sites have been highly modified and cannot be classified into site series. Some areas in this ecotype, such as Lagoon West and Matilda Park, have large, dense infestations of invasive species such as Scotch broom (*Cytisus scoparius*) and Himalayan blackberry (*Rubus bifrons*).

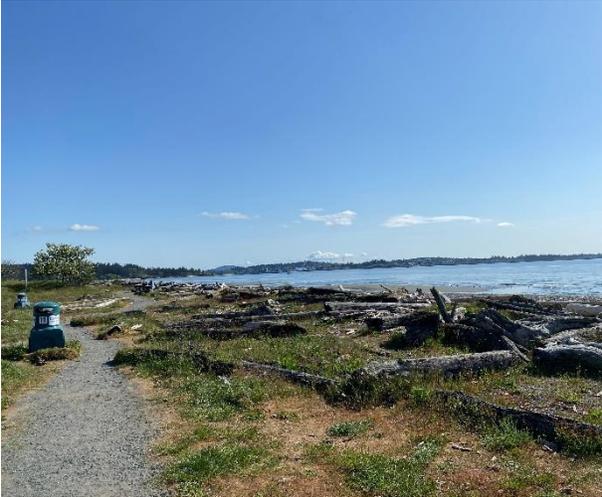
Photo: Representative view of the coastal dune ecosystem in **Ecotype D**.

The coastal dune ecosystem is present between the beach and human-modified areas of the peninsula. This area is slightly higher in elevation than the beach ecosystem and is only inundated during large storm events. The coastal dune ecosystem has a sand substrate with dominant native vegetation including beach pea (*Lathyrus japonicus*), silver beachweed (*Ambrosia chamissonis*), Oregon gumweed (*Grindelia stricta*), dune wildrye (*Leymus mollis*), and yarrow (*Achillea millefolium*). A significant amount of driftwood is scattered across the coastal dune area.

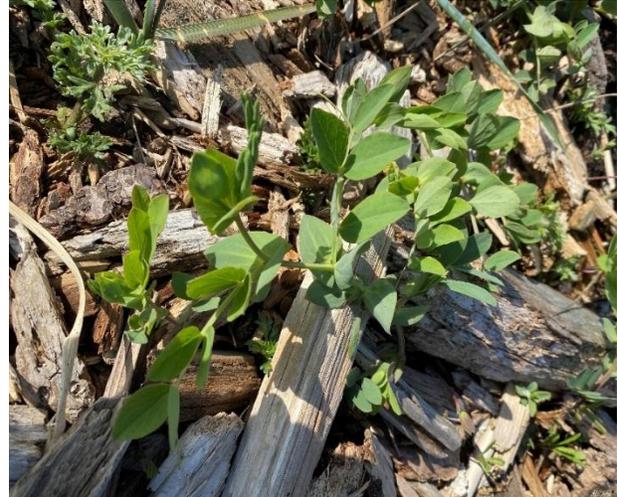
Photo: Beach pea is commonly observed in the coastal dune ecosystem of **Ecotype D**.

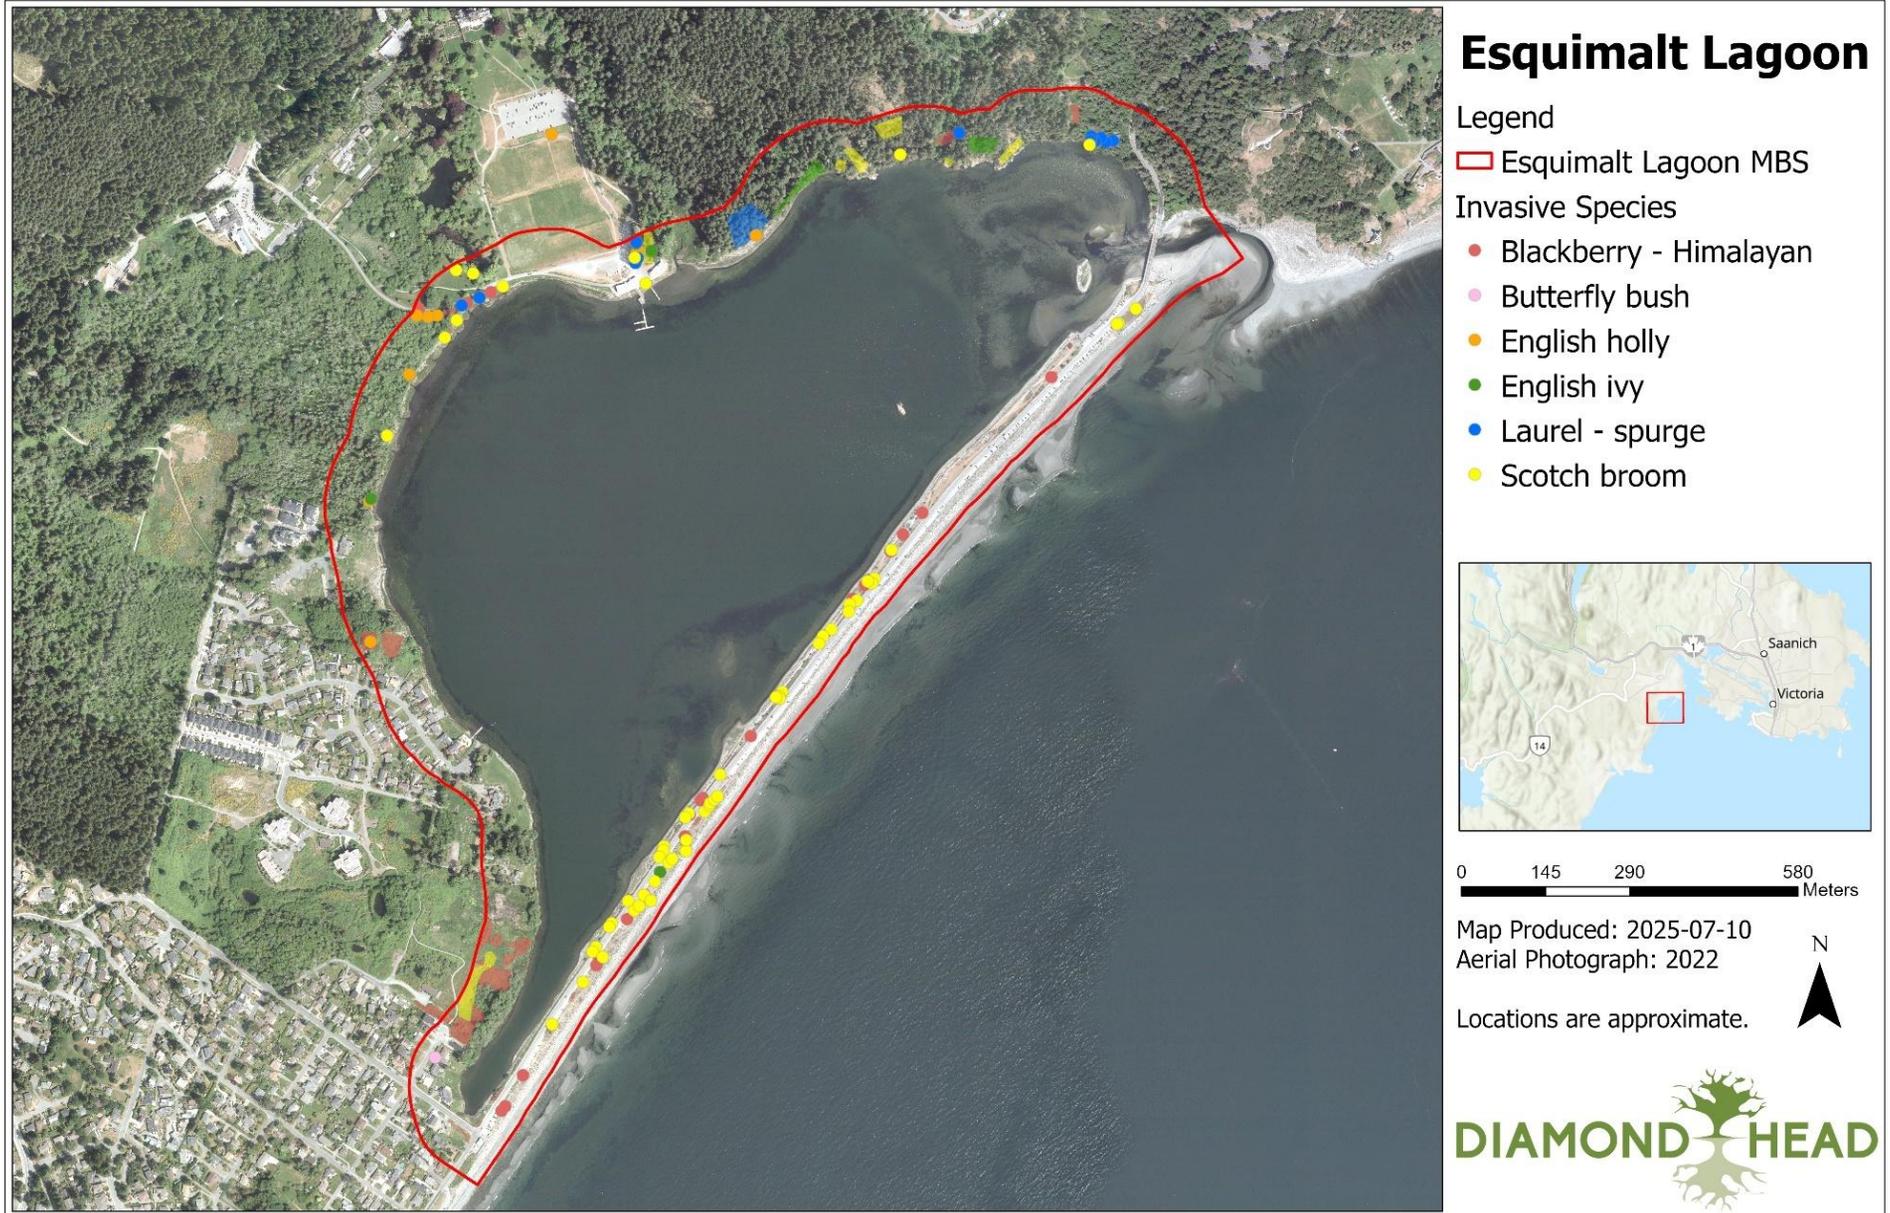
Figure 4. Invasive plant species mapped within the Esquimalt Lagoon MBS during the field assessment on April 30 and May 1, 2025.

Invasive coverage within the study area are detailed in Table 1. These coverages are an overestimation of the actual area covered, as invasive plants often overlap one another. Himalayan blackberry (*Rubus bifrons*) was by far the most common species observed in the study area, followed by Scotch broom

(*Cytisus scoparius*). Both of these species were observed scattered along the side of roads and trails on the Coburg Peninsula as well as large, dense infestations near the shoreline within Lagoon West Park.

As part of the field assessment for this report, invasive species were mapped on public property within the study area (Figure 4). The field inventory was carried out using ESRI's ArcGIS Collector app loaded onto iPads.

Every species occurrence was denoted as a point feature. All infestation area measurements are visual estimations. The smallest measured unit is one square meter. Area estimations are made as contiguous measurements of impacted square meters (i.e., if there are 10 knotweed stems within two contiguous square meters, the impacted area is recorded as two square meters). When an occurrence impacted an area greater than 25 m², a polygon feature was used to record the extent. Polygon features recorded the percent cover for the species indicated. Percent cover was defined as the percent of ground affected by the species.

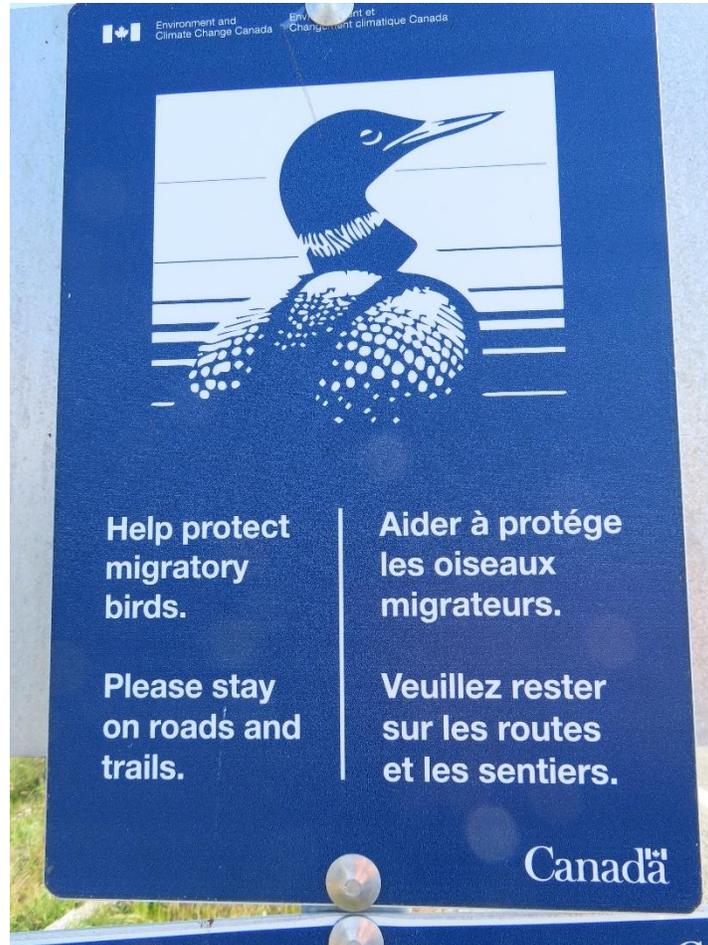
The dunes on the Coburg Peninsula are highly sensitive to being trampled by pedestrians and pets. Native vegetation such as dunegrass plays a critical role in stabilizing sand and supporting rare ecosystems. Trampling destroys root systems, reduces vegetative cover, and increases erosion risk, particularly during storm events (Flottorp et al., 2013; Watson & Christian, 2013). During the field assessment for this report, it was observed that there are numerous trails to access and traverse the beach on the ocean-facing side of the Coburg Peninsula. These trails also appeared to be used more frequently by visitors. On the lagoon-facing side, there were typically only one or two well-defined trails extending along the peninsula.

A sign located along the Coburg Peninsula requesting visitors to stay on roads and trails.

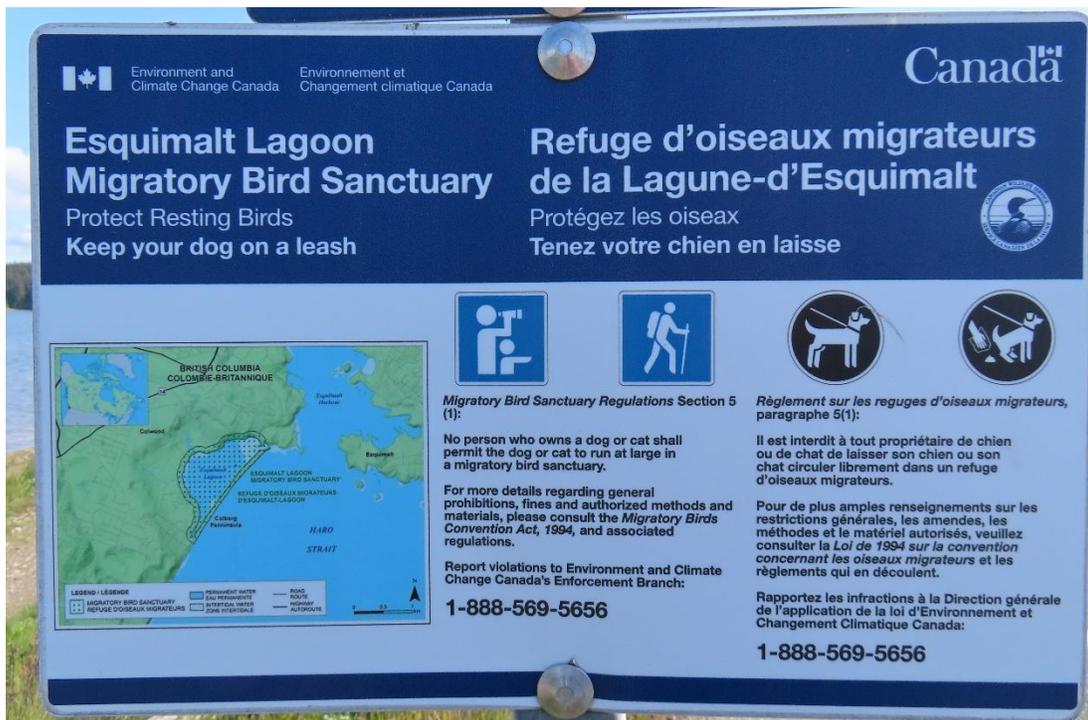
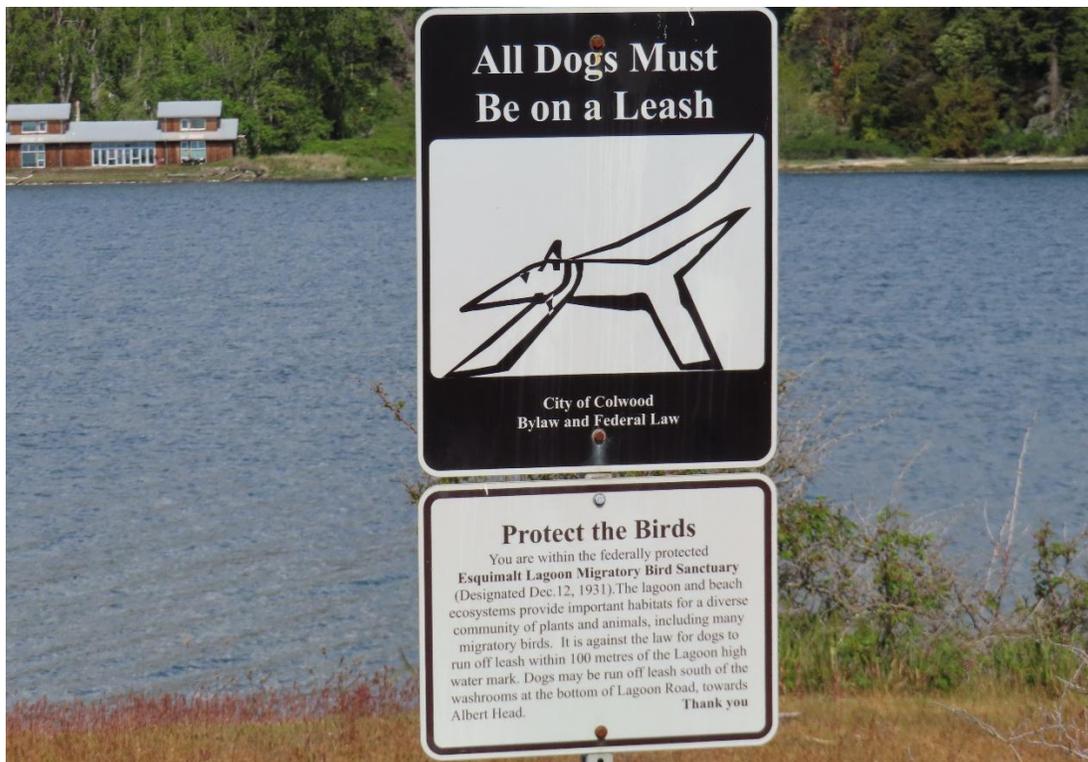
Dogs off-leash pose multiple threats: trampling sensitive dune vegetation, disturbing wildlife (especially birds), and enabling invasive plant spread through disturbed soils. While the Esquimalt Lagoon Migratory Bird Sanctuary is designated as an on-leash area, compliance remains an issue—suggesting a need for stronger enforcement or education campaigns (Flottorp et al., 2013; Goulet et al., 2013). Numerous off-leash dogs were observed along the Coburg Peninsula during the field assessment for this report. The majority of these dogs were on the ocean-facing side of the peninsula, below the high-water mark, where there was no vegetation. However, some dogs were observed running within areas of dune vegetation. One instance of an off-leash dog on the lagoon-facing side of the peninsula was observed near the bridge at the northeast end of the spit. A bird watcher informed the dog owner that pets must be on a leash in this area, and the dog owner quickly put their pet on a leash.

Signage along the Coburg Peninsula requesting that dogs be kept on a leash.

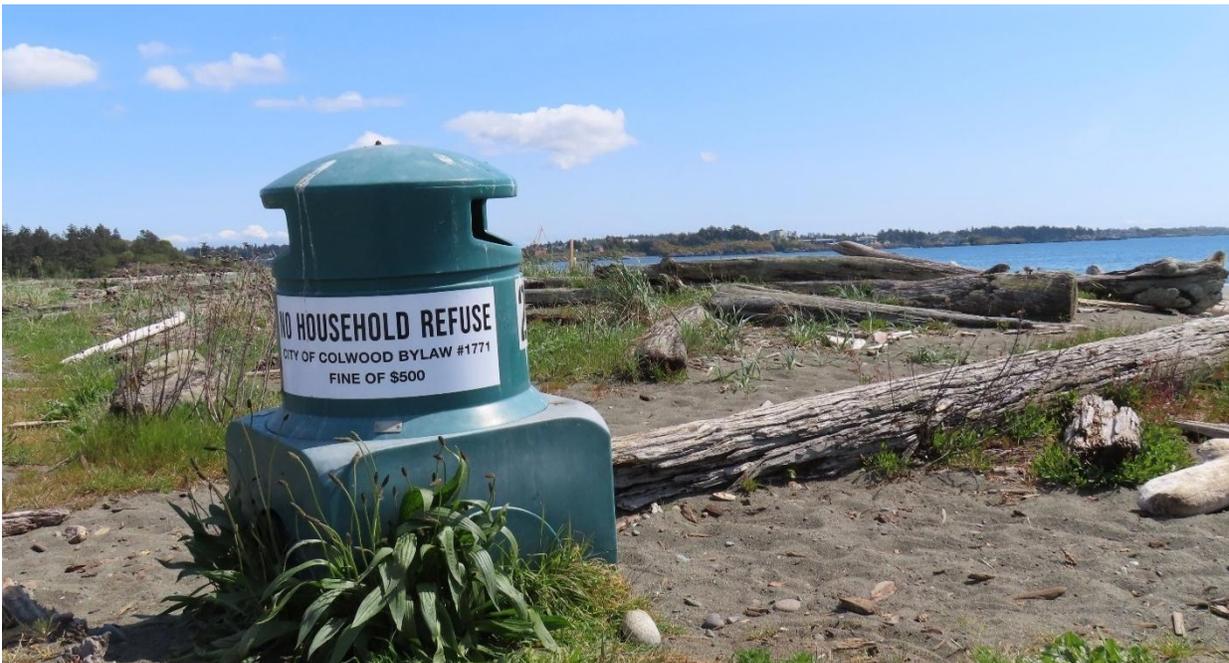
Across the length of the Coburg Peninsula, there are numerous garbage cans located along Ocean Boulevard, mostly beside parking areas. Despite this, some instances of littering were observed scattered across the peninsula. Research by Buchan et al. (2013) found that littering is often associated with vehicle-based users of the lagoon, who will come and stay parked in their car to enjoy the view. Litter not only pollutes the environment but also detracts from the area's cultural and aesthetic values. In contrast, pedestrian users are more likely to engage in stewardship, highlighting a divide in user impact patterns (Buchan et al., 2013). During the field assessment for this report, a group of pedestrian users on the lagoon side of the peninsula were observed cleaning up litter as they walked. In addition to this, ELSI partners with the Surfrider Foundation South Vancouver Island to host an annual beach clean-up at Esquimalt Lagoon.

One of many garbage bins adjacent to parking areas on Ocean Boulevard along the Coburg Peninsula
